Cabot Oil & Gas Corporation

# DEP Meeting

October 11, 2011

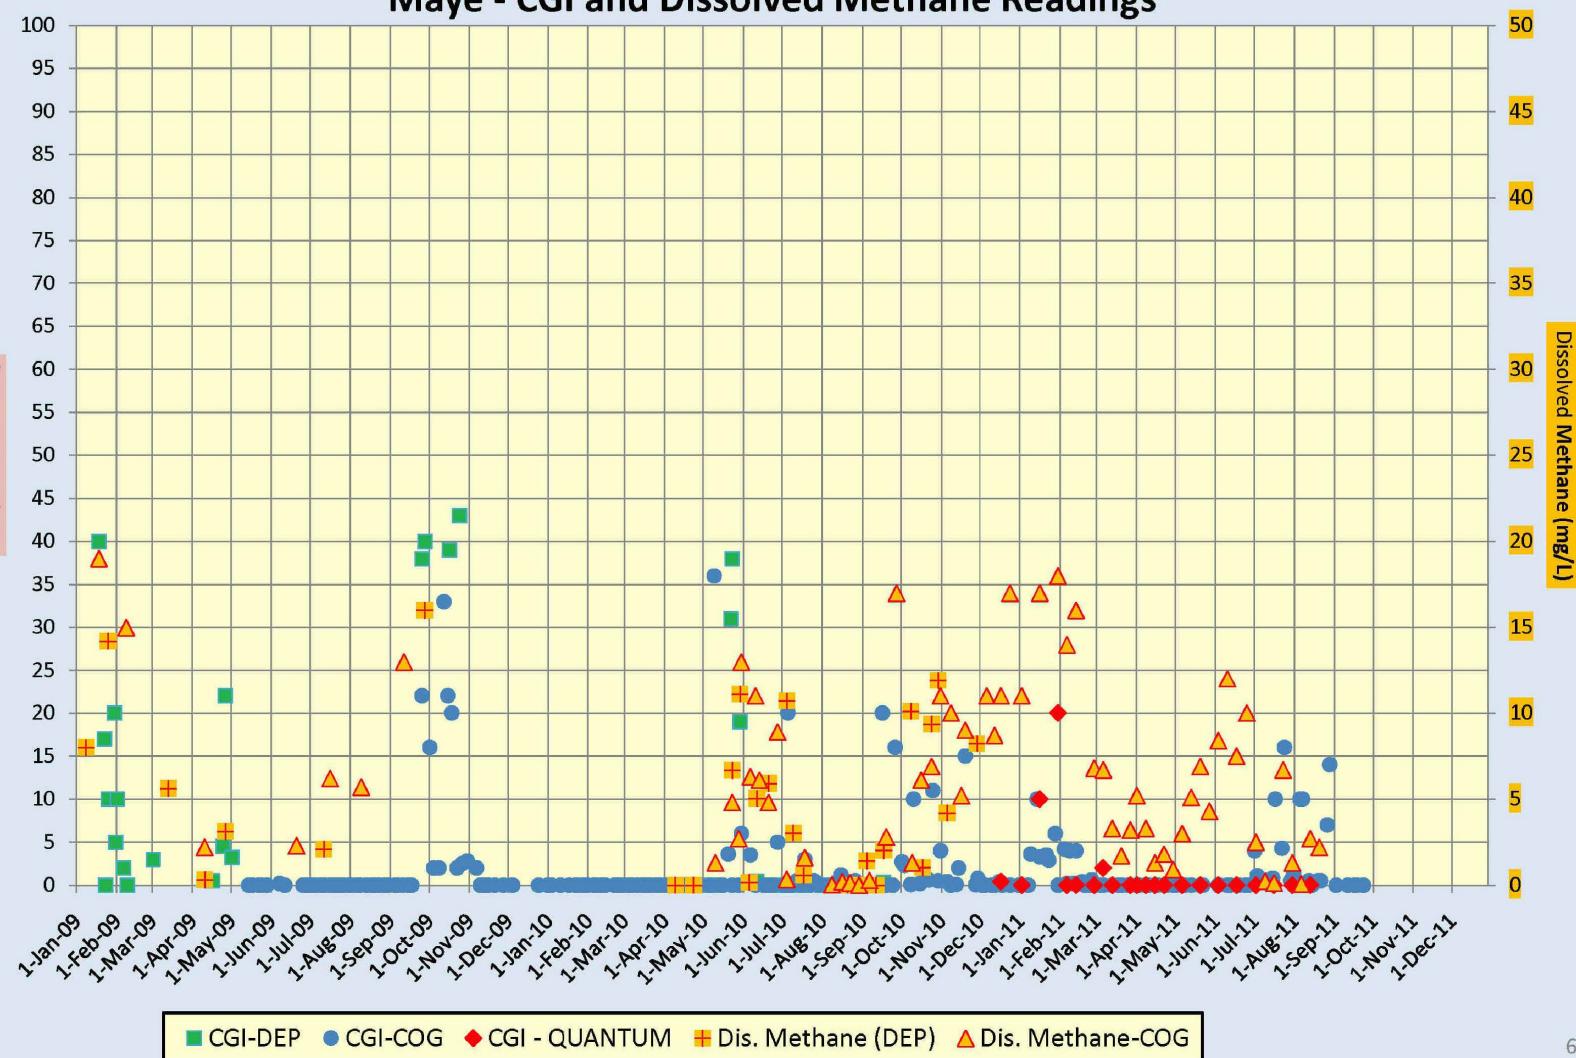
## Maye – CGI and Dissolved Methane Graphs

Maye - CGI and Dissolved Methane Readings

<b>Water Well - Owner</b>	Timothy and Deborah Maye
<b>Exceed Primary:</b>	None
<b>Exceed Secondary:</b>	None
<b>Dissolved Gas:</b>	Most Recent Result = 2.2 mg/L (08/24/11)
Before Treatment:	2.2 mg/L (08/24/11)
After Treatment:	0.099 mg/L (08/24/11) System installed May 2010.
<b>Gas Wells ≤ 1000':</b>	None
<b>Gas Wells 1000' - 2500':</b>	Baker 1V - P&A Baker 3H Gesford 5H Gesford 1V
<b>Plan Forward:</b>	Continue to monitor as per CO&SA.
<b>Comments:</b>	Received escrow funds. Installed treatment system. Receiving bottle water.

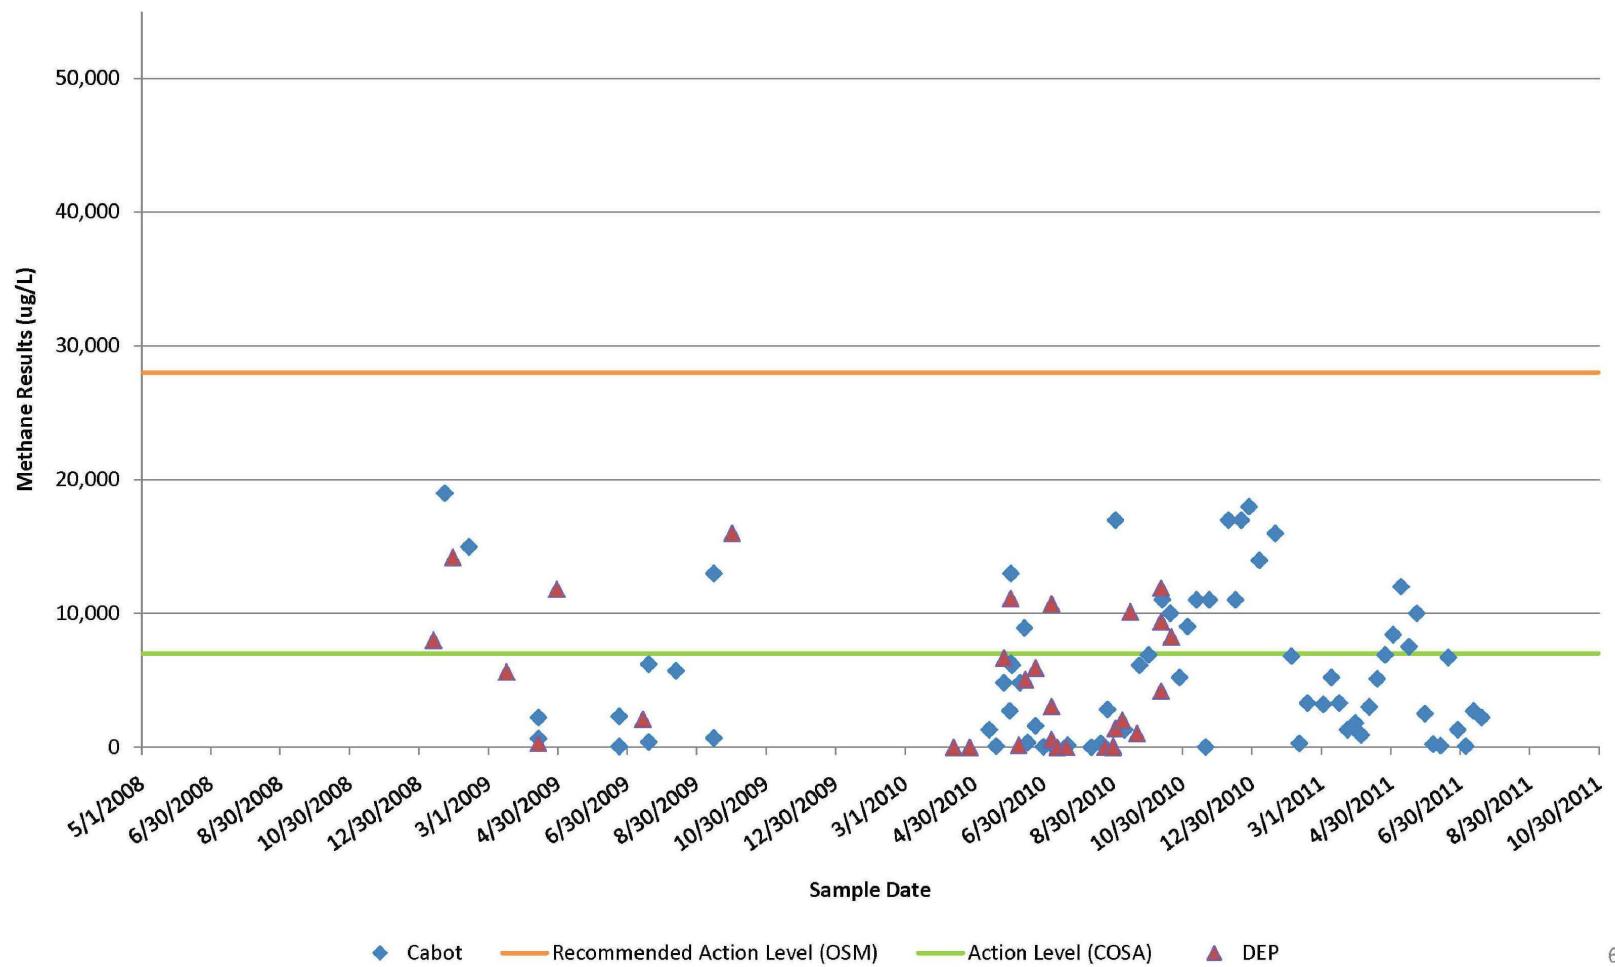
# Maye, Tim and Deb – CH<sub>4</sub> results

## Maye, Tim and Deb Methane Sample Results

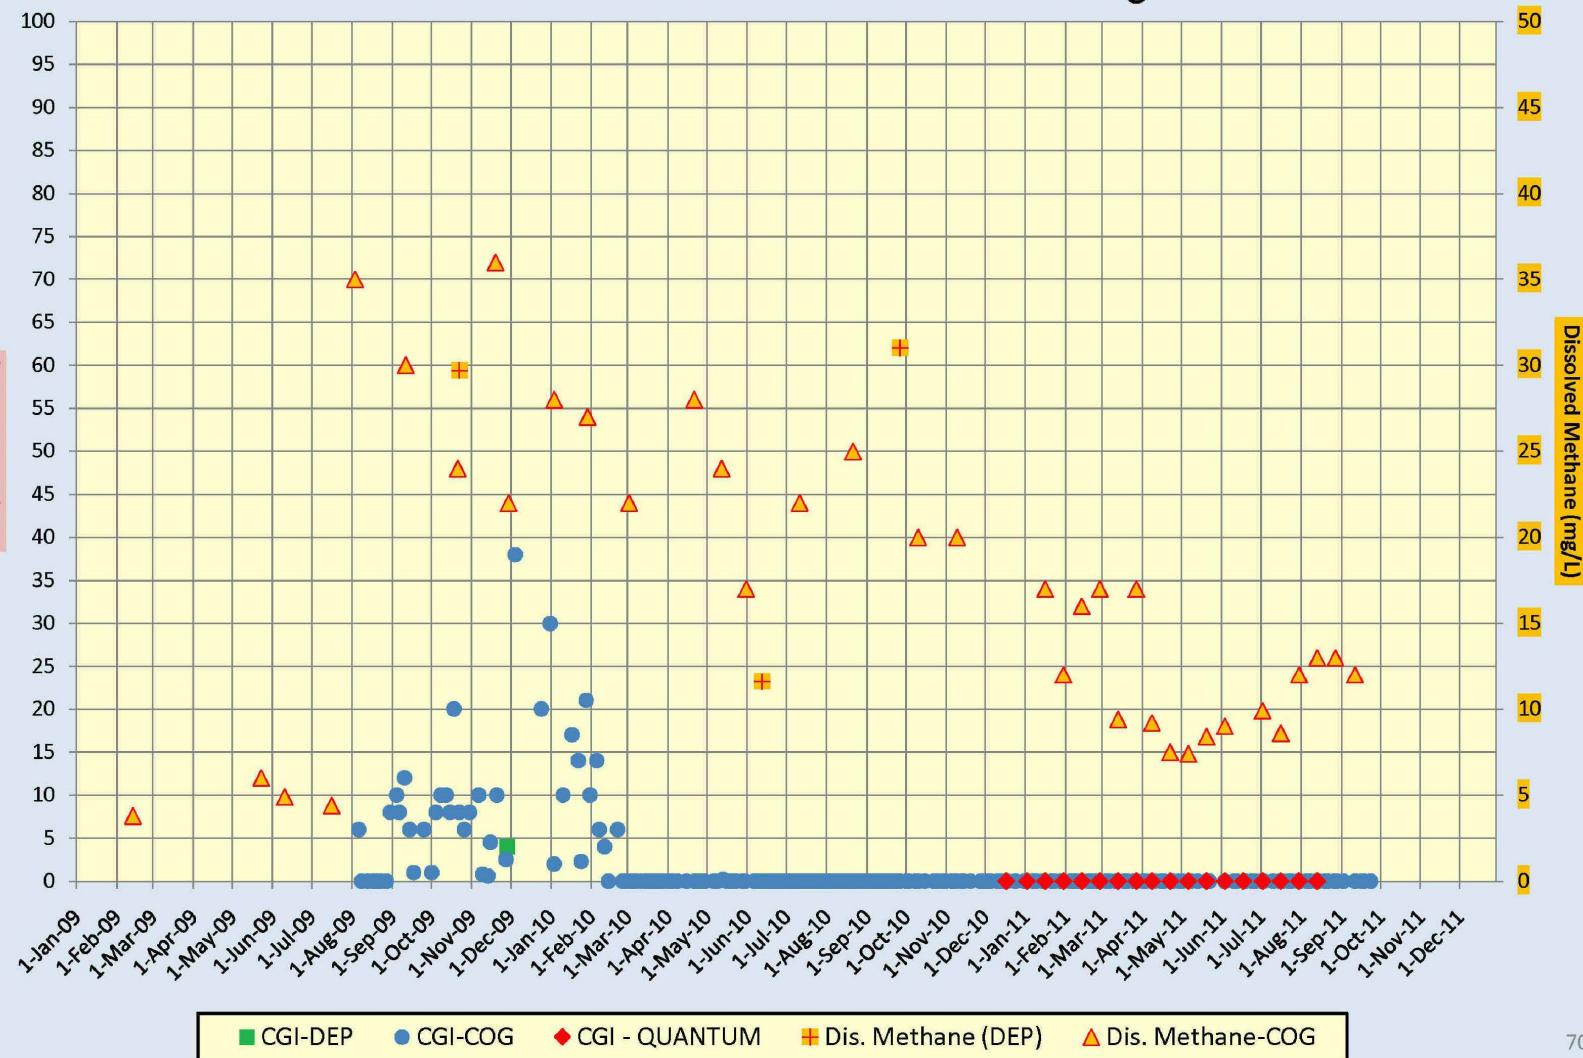
# Salsman – CGI and Dissolved Methane Graphs

## Salsman - CGI and Dissolved Methane Readings

<b>Water Well - Owner</b>	Loren Salsman
<b>Exceed Primary:</b>	None
<b>Exceed Secondary:</b>	Iron Manganese
<b>Dissolved Gas:</b> Before Treatment: After Treatment:	Most Recent Result = 12 mg/L (09/15/11) 12 mg/L (08/03/11) 0.19 mg/L (08/03/11) Mobile system installed October 2010 and permanent system installed November 2010.
<b>Gas Wells ≤ 1000':</b>	Ratzel 1H Ratzel 3V Ratzel 2H
<b>Gas Wells 1000' - 2500':</b>	None
<b>Plan Forward:</b>	Continue to monitor as per CO&SA.
<b>Comments:</b>	Microbial Gas. Received escrow funds. Installed treatment system.

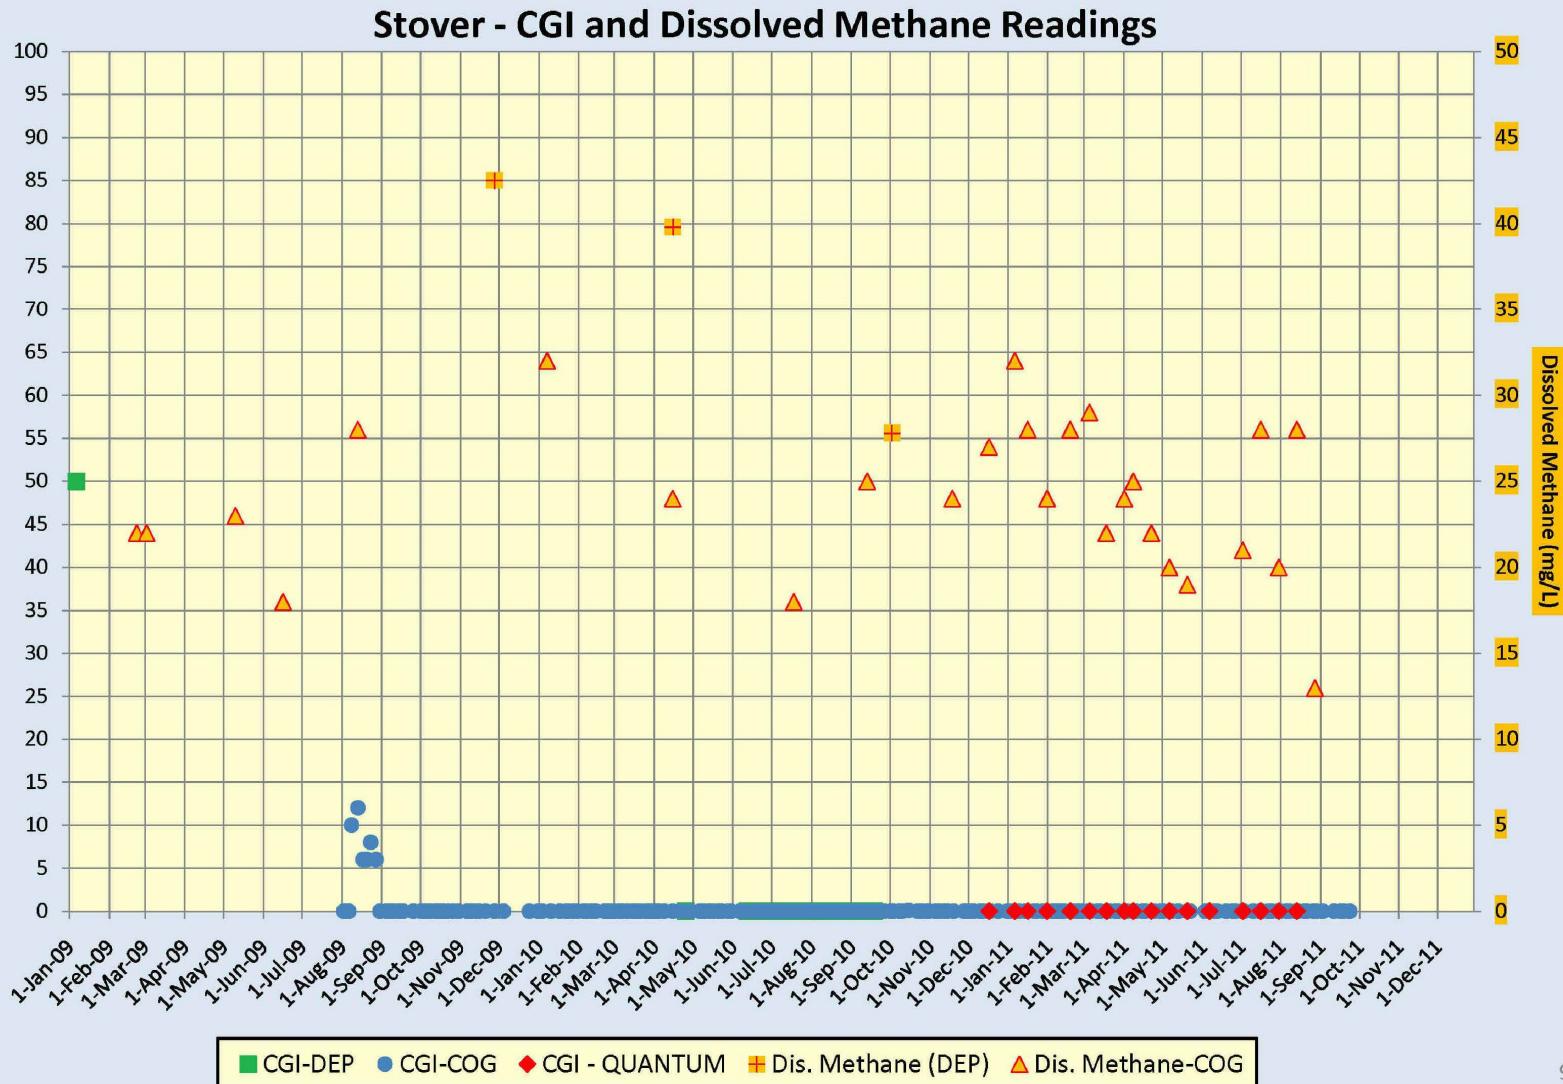
## Stover – CGI and Dissolved Methane Graphs

<b>Water Well - Owner</b>	Richard Stover
<b>Exceed Primary:</b>	Barium
<b>Exceed Secondary:</b>	Manganese
<b>Dissolved Gas:</b>	Most Recent Result = 13 mg/L (08/31/11)
Before Treatment:	Data not yet available.
After Treatment:	Data not yet available. System installed August 2011
<b>Gas Wells ≤ 1000':</b>	None
<b>Gas Wells 1000' - 2500':</b>	Ratzel 1H Ratzel 3V Ratzel 2H
<b>Plan Forward:</b>	Continue to monitor as per CO&SA.
<b>Comments:</b>	Received escrow funds. Installed treatment system and RO system. Not primary residence.

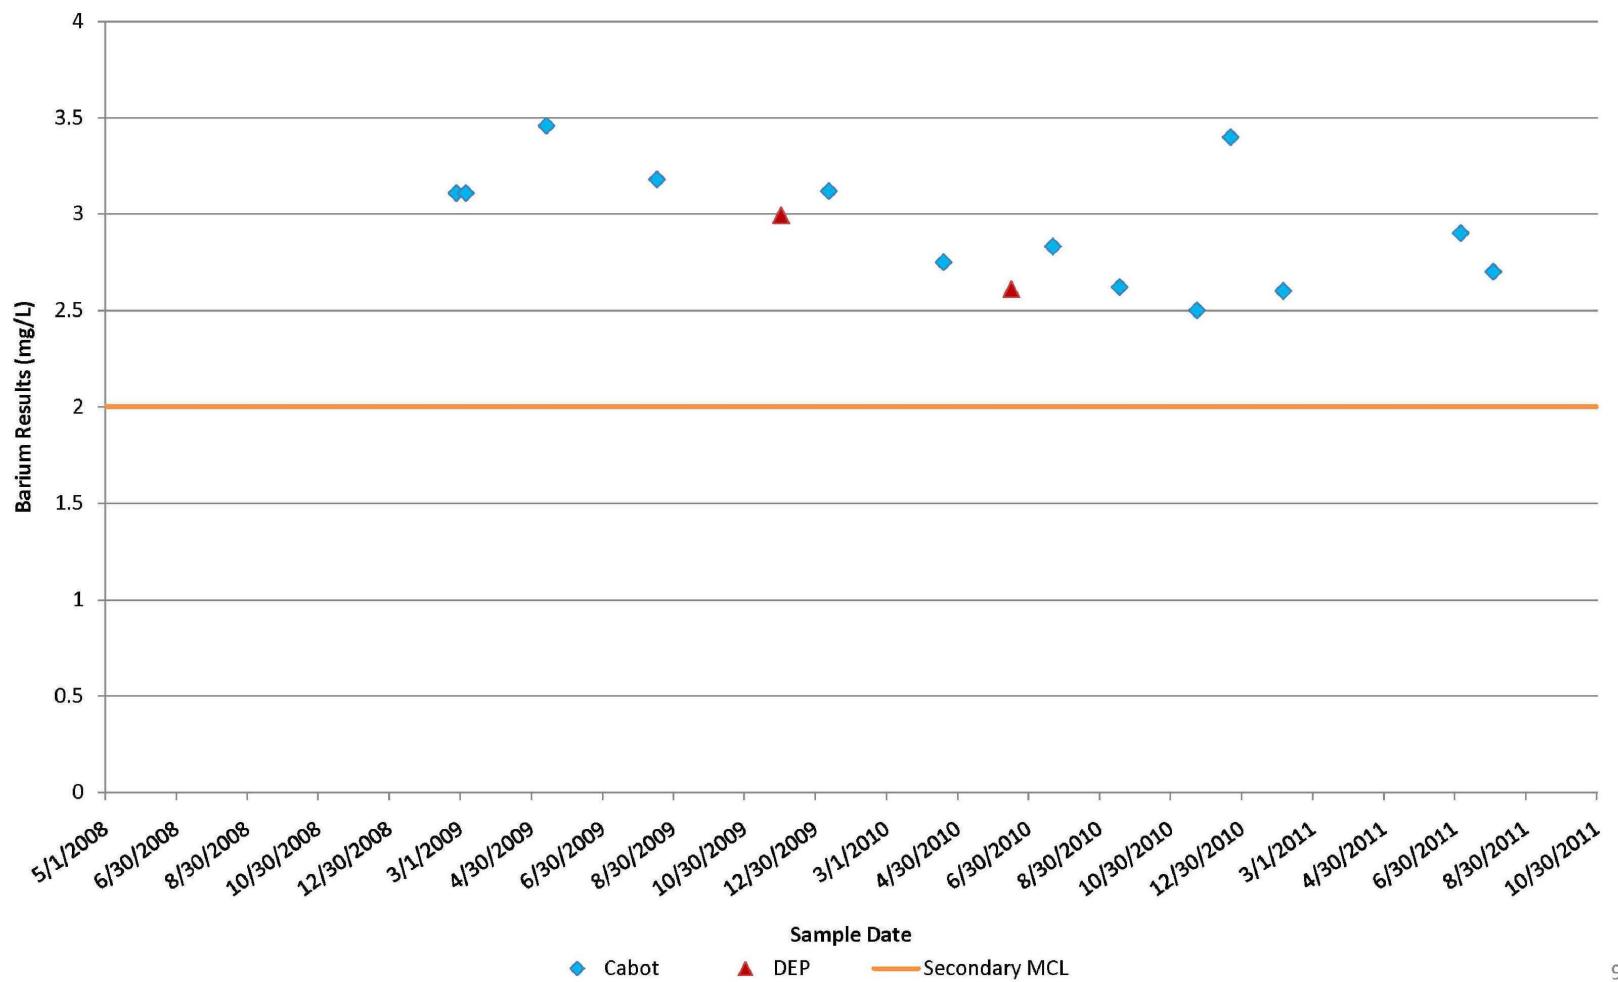
## Stover, Richard – Ba results

**Stover, Richard  
Barium Sample Results**

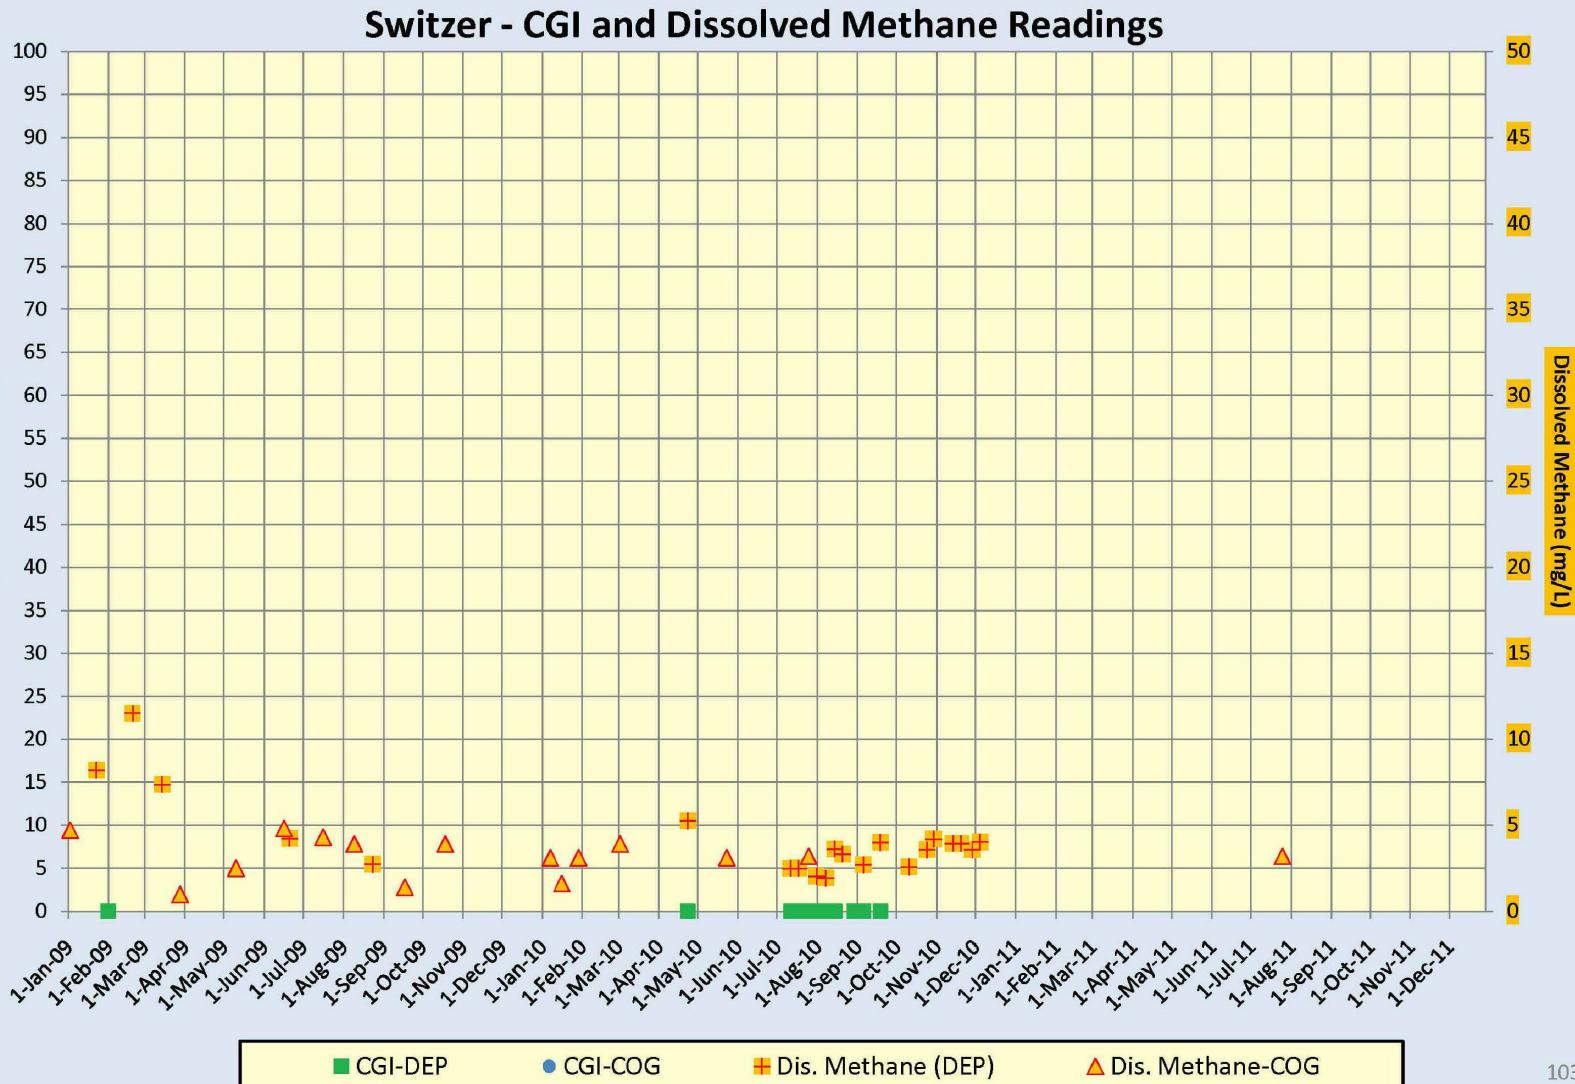
## Switzer – CGI and Dissolved Methane Graphs

<b>Water Well - Owner</b>	Jimmy and Victoria Switzer		
<b>Exceed Primary:</b>	None		
<b>Exceed Secondary:</b>	pH		
<b>Dissolved Gas:</b>	Most Recent Result = 3.18 mg/L (07/29/11)		
Before Treatment:	N/A	Ely 6H	
After Treatment:	N/A	Lewis 1V	
<b>Gas Wells ≤ 1000':</b>	Lewis 2V		
<b>Gas Wells 1000' - 2500':</b>	Costello 1V Ely 2V Ely 4V	Ely 6H Lewis 1V	
<b>Plan Forward:</b>	Offer treatment system.		
<b>Comments:</b>	Receiving bottled water. Refusing to allow sampling. Refused treatment system. 75/2X Rule per COSA not exceeded since 2/23/09.

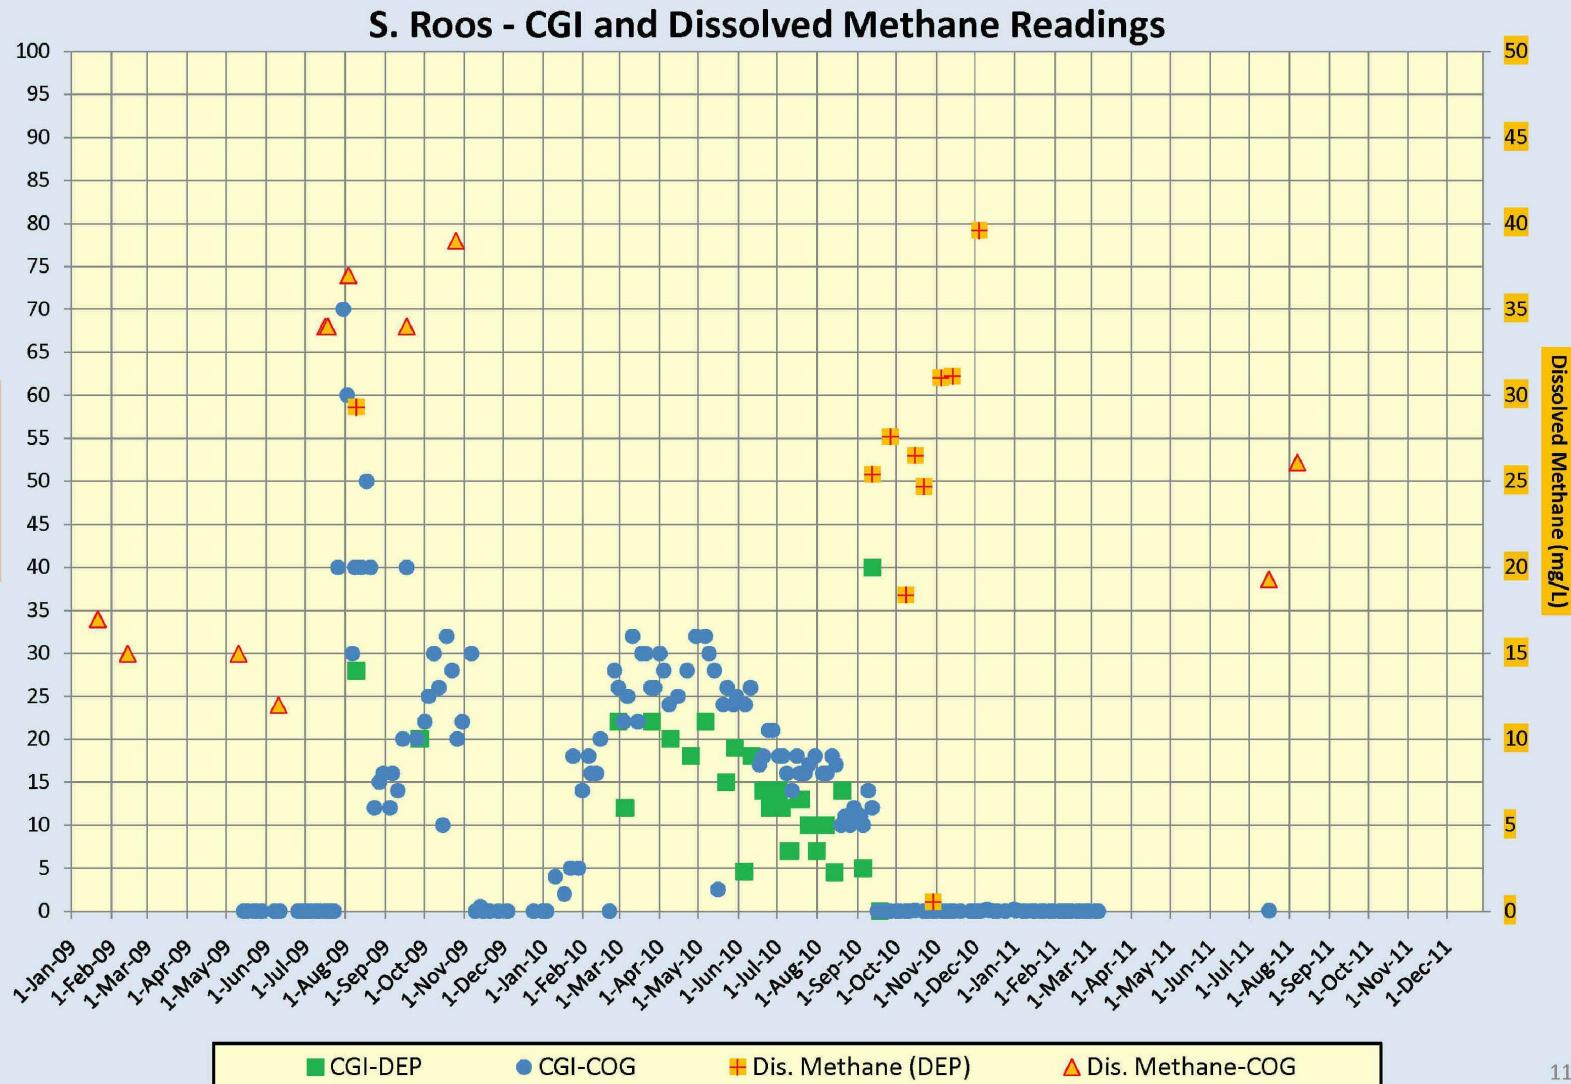
## Roos – CGI and Dissolved Methane Graphs

<b>Water Well - Owner</b>	Eric B.J. and Susan Roos
<b>Exceed Primary:</b>	None
<b>Exceed Secondary:</b>	Iron Manganese
<b>Dissolved Gas:</b>	Most Recent Result =26.1 mg/L (8/11/2011)
Before Treatment:	N/A
After Treatment:	N/A
<b>Gas Wells ≤ 1000':</b>	Ratzel 1H Ratzel 2H Ratzel 3V
<b>Gas Wells 1000' - 2500':</b>	None
<b>Plan Forward:</b>	Offer treatment system. Continue to monitor as per CO&SA
<b>Comments:</b>	Microbial Gas. Receiving bottled and bulk water. Refused treatment system.

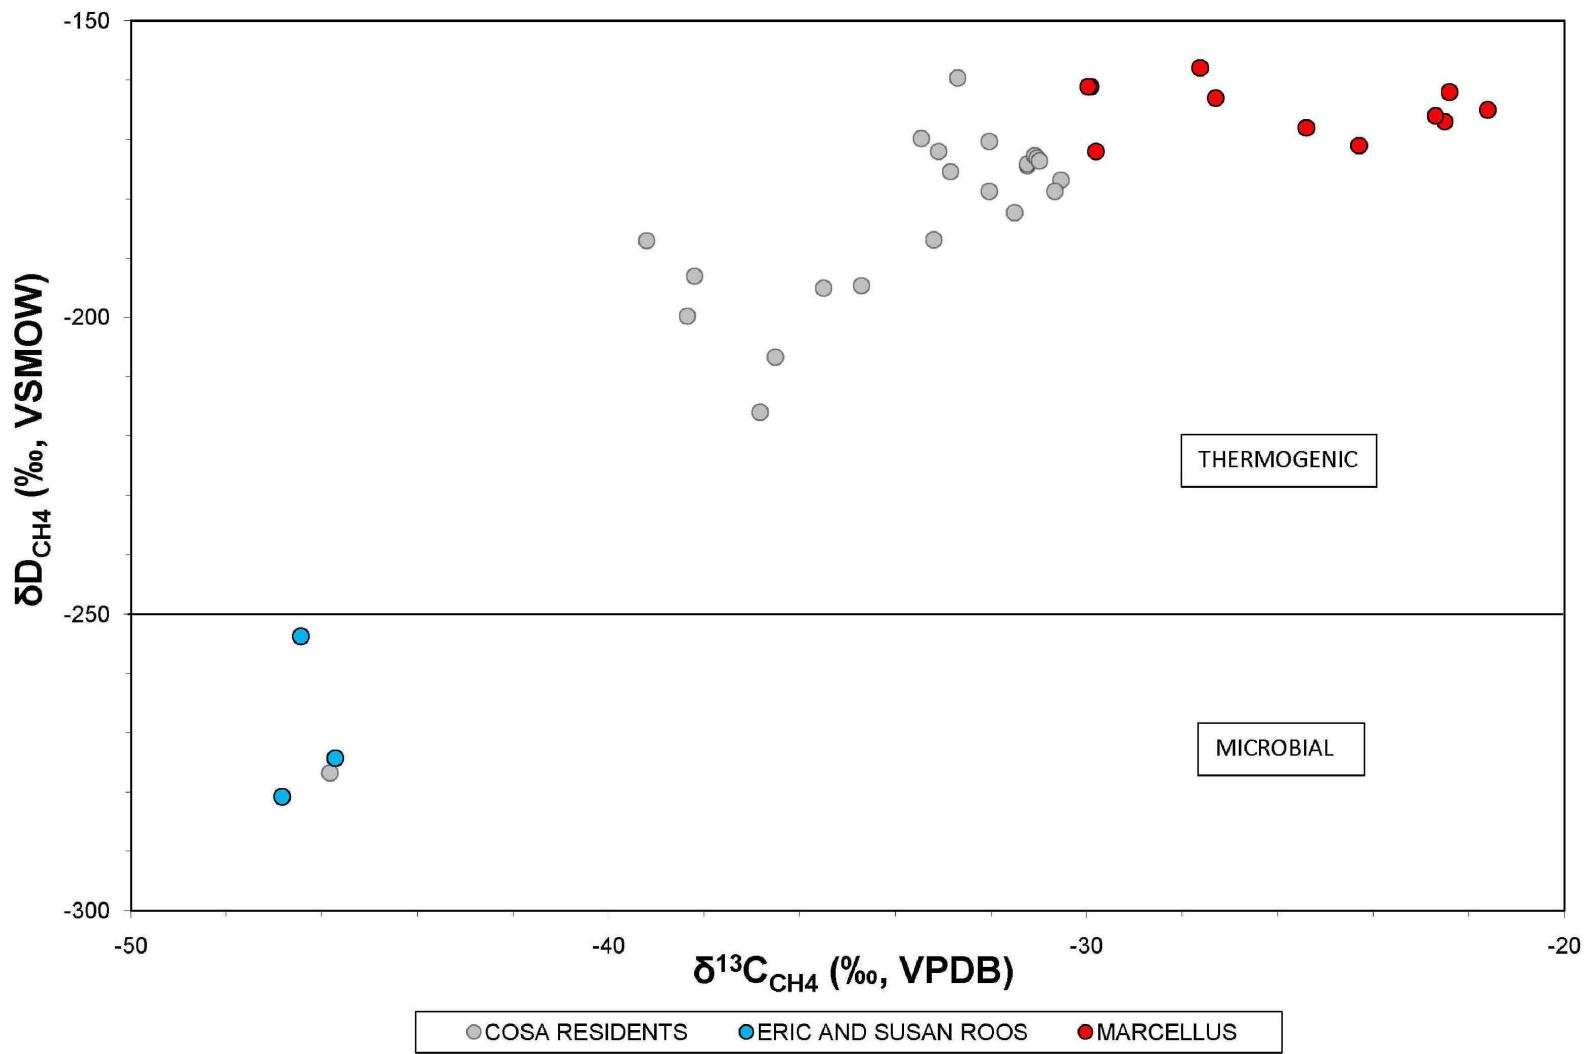
## Roos, Eric and Susan – Isotopes
